**CITY OF GRAND LEDGE
SEVEN ISLANDS DAM REPAIR OPTIONS**

NOVEMBER 2014
PROJECT NO. 13008.00

City of Grand Ledge Seven Islands (Mudges) Dam Repair Options

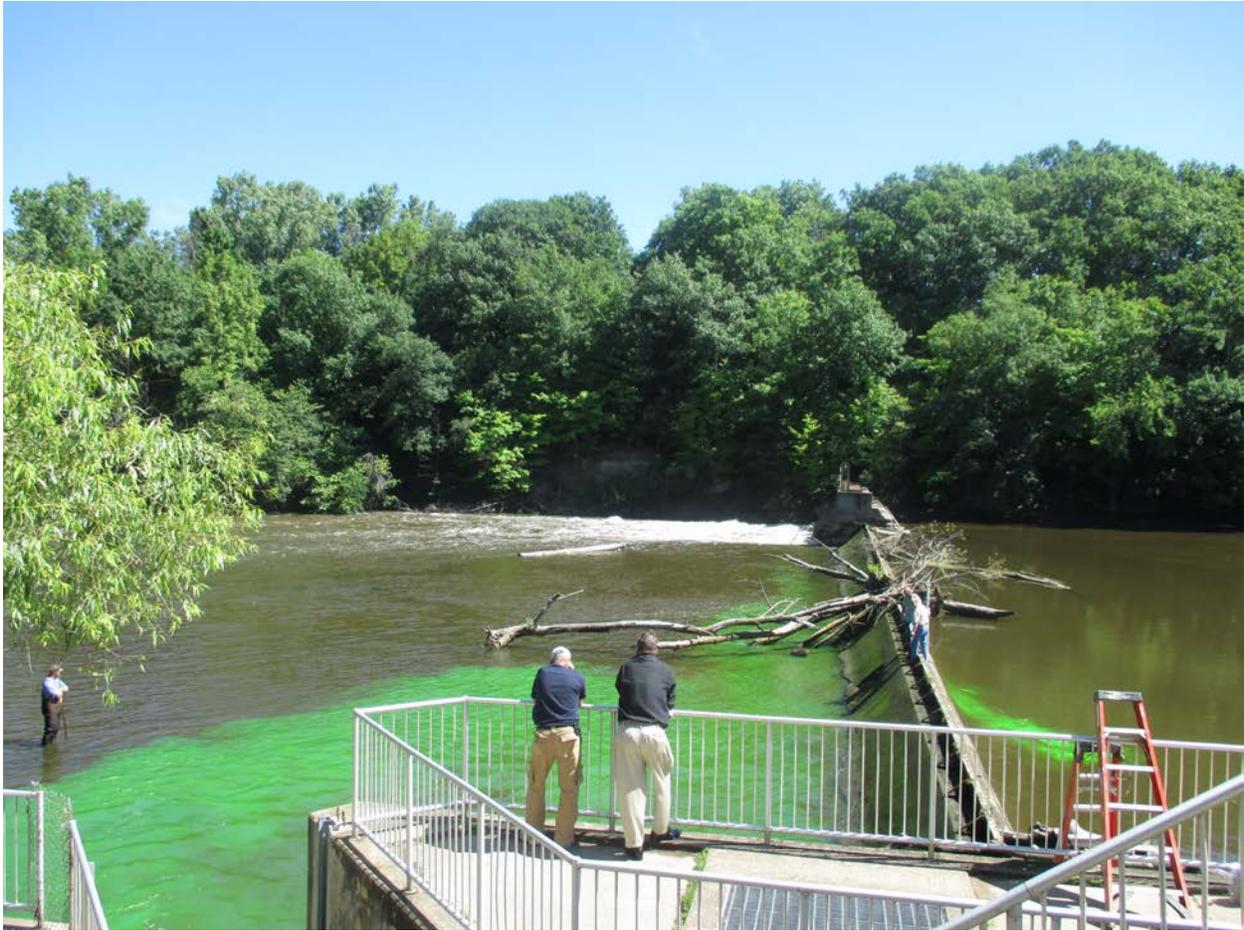
On July 3, 2014, together with Public Service staff, the dye test was completed. Dye was observed downstream at the joint between the spillway and the fish ladder. No other dye was observed flowing below the spillway, indicating that the main structure is not being undercut. The failure of that joint can be repaired.

Dye Test completed July 3, 2014

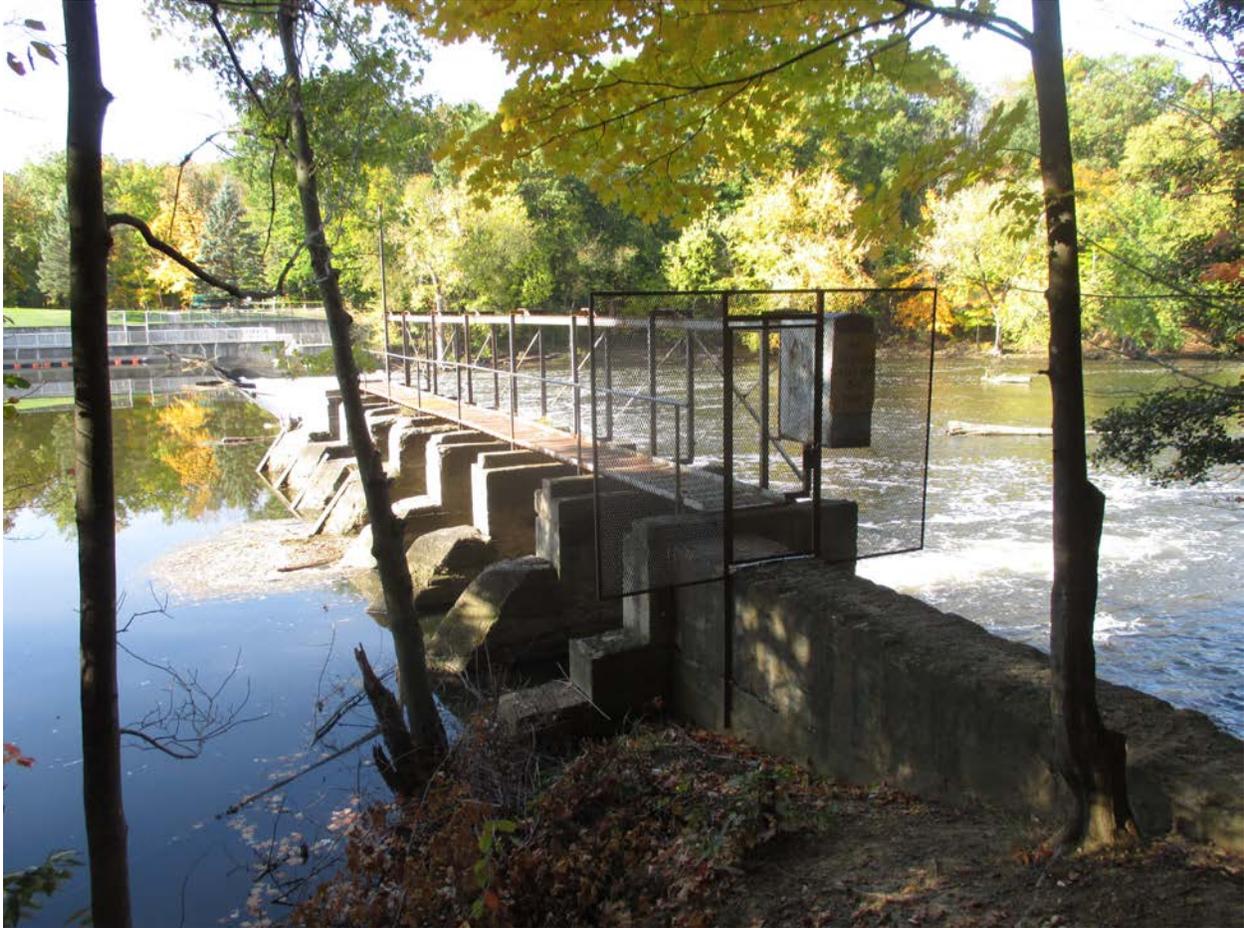
When the gates were raised (open) for the drawdown, Public Service staff became concerned about the possibility of the gates not holding together when lowered. Replacement gates were constructed and installed. In addition, a drive was constructed on the north side for equipment to access the gates. Fencing was installed to prevent trespassers from climbing on the gate structure.

Temporary Repairs: Replacement Gates and Fencing

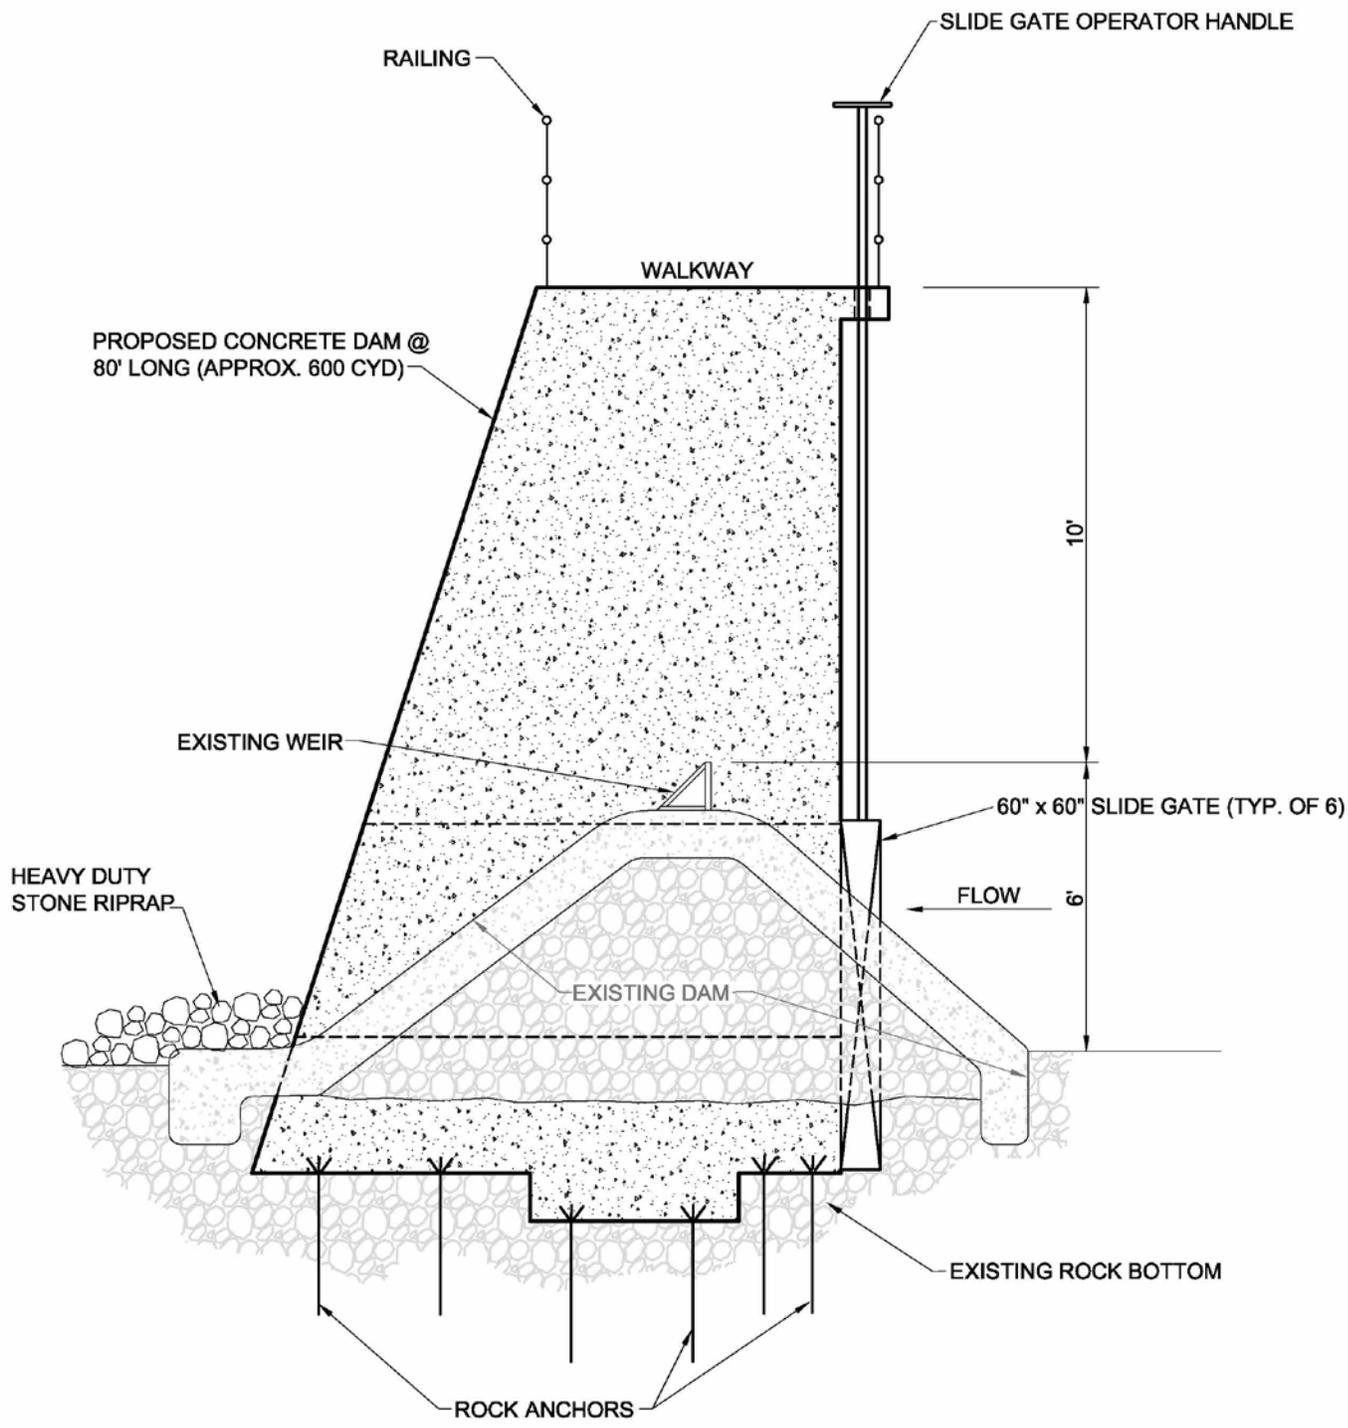
DAM SECTION
 1/4"=1'-0"

Option 1 consists of an entirely new dam connecting to the existing spillway, constructed by pouring an overlapping structure over the spillway. The dam would extend northeasterly and tie into the north bank.

The existing gates would be replaced with six (6) 5-foot by 5-foot gates with handwheel operators. An overhead crane is an option with gravity closure. The walkway would be integrated with the concrete dam by safety rails.

Option 1: Replace the gate structure and repair the spillway. This option includes new gates and supports, bank restoration, site access improvements, new catwalk and gate lifting mechanism. We recommend that the toe of the spillway be repaired at the same time to address the areas where the apron have broken off and settled.

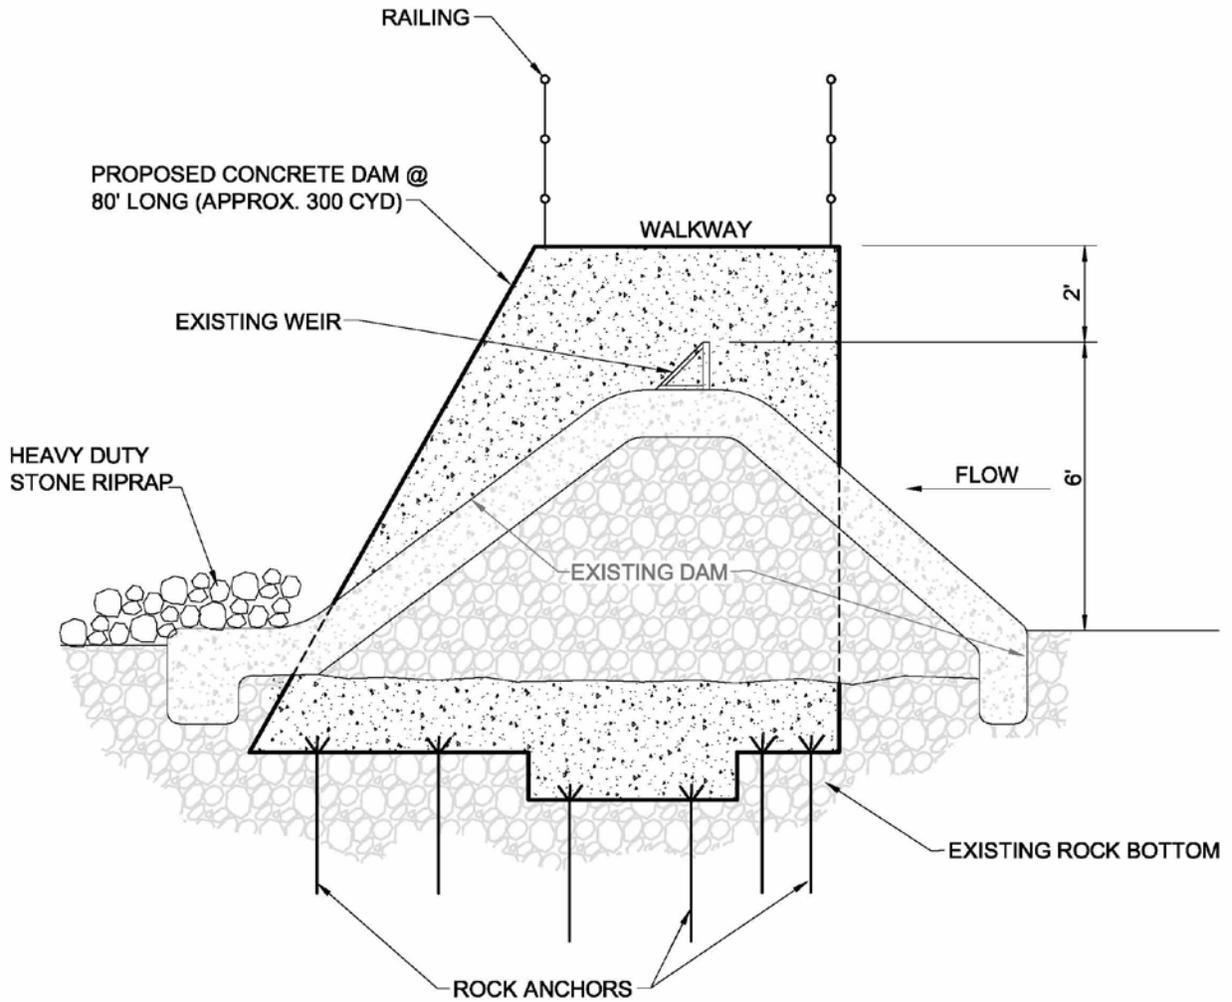
DAM SECTION

During normal river stages, water would flow over the spillway as it currently does. As in Option 1, the toe of the spillway would be reinforced.

Option 2 (revised): *Construct a new dam structure that will allow water to flow over at flood stage.*

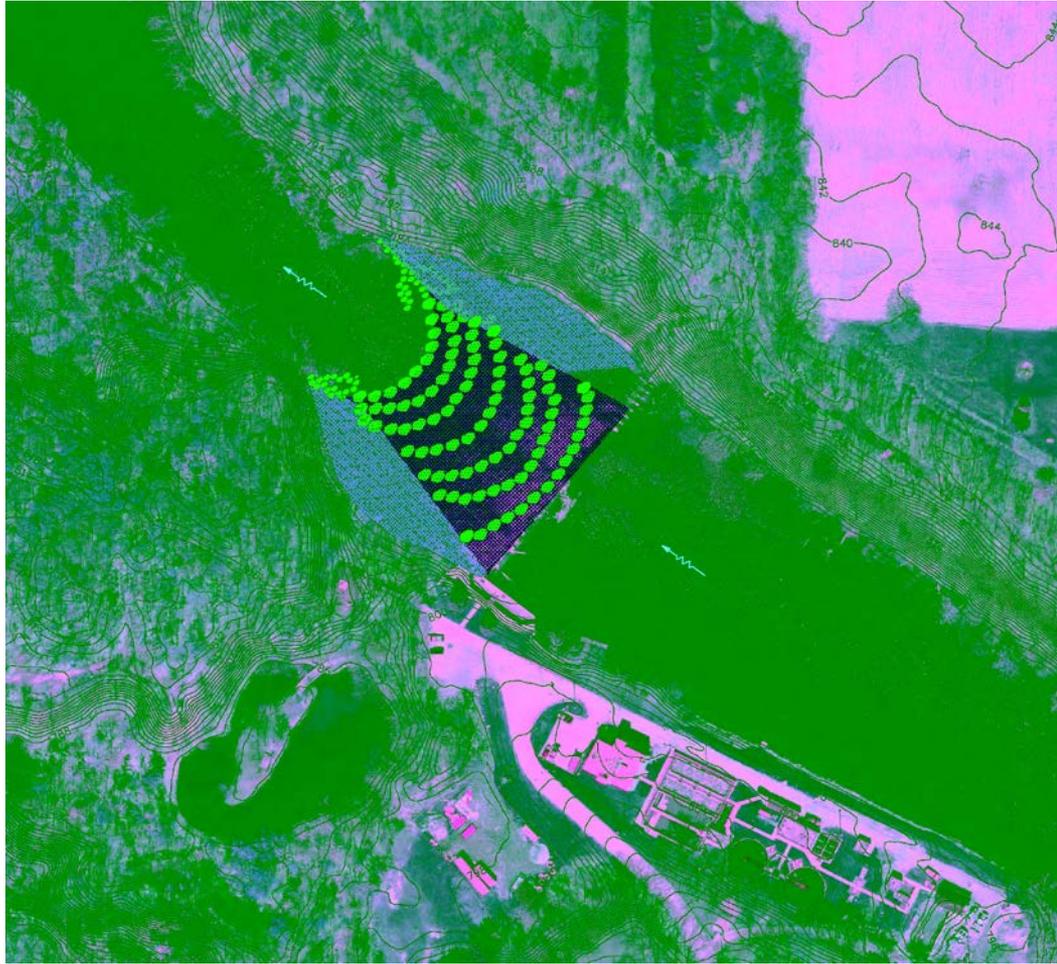
Proposed Dam
Improvements
Conceptual Layout

Option 3: Remove the Dam completely, maintaining upstream water levels. The Dam could be removed and replaced with a series of channels and pools which would maintain the water elevation upstream and gradually step down to the downstream elevation. This would take place over several hundred feet and be designed so as not to impede fish movement.
