Island Park Tree Assessment

Grand Ledge Michigan

By: The Visiting Arborist

February 2019

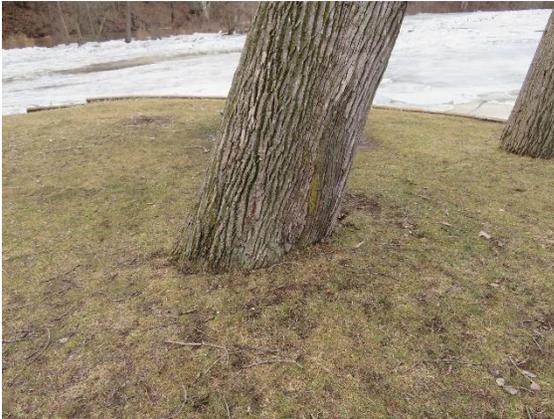
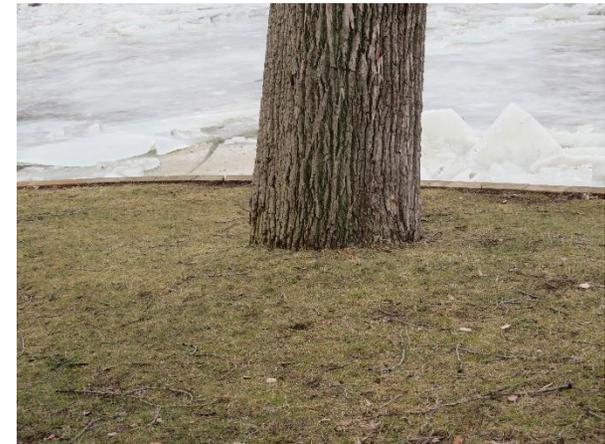
Point 1 is two cottonwood trees with 50 inch diameter and are 50+ feet tall located on the far east end of park. The overall health of the trees appears good. Both trees lean but appear stable. The root systems and base of the trees have been buried but how far is unknown. There are no signs of rot or fungi at the base of the trees which would be typical of trunk or root rot. Staff should inspect the trees for mushrooms or other signs of rot every time they visit the park. There is some deadwood in the crown of both trees.

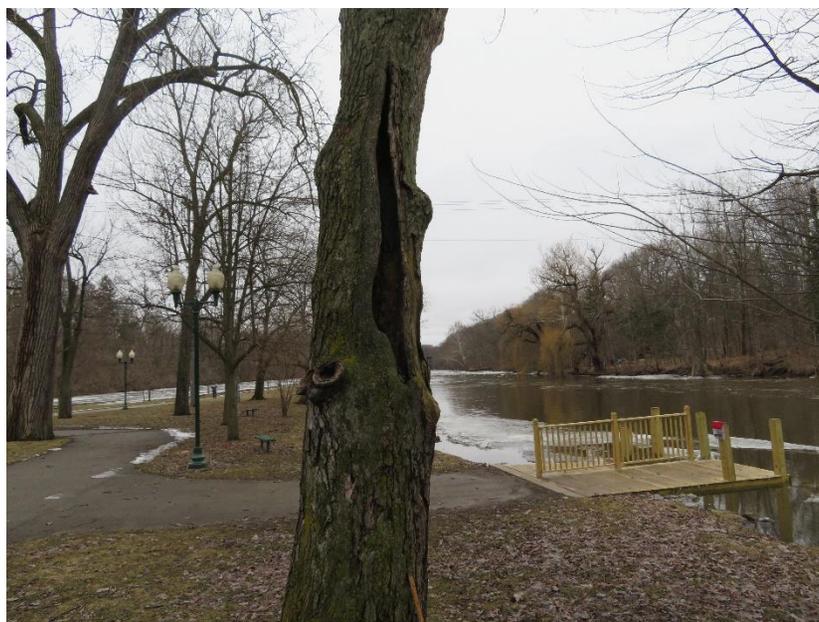
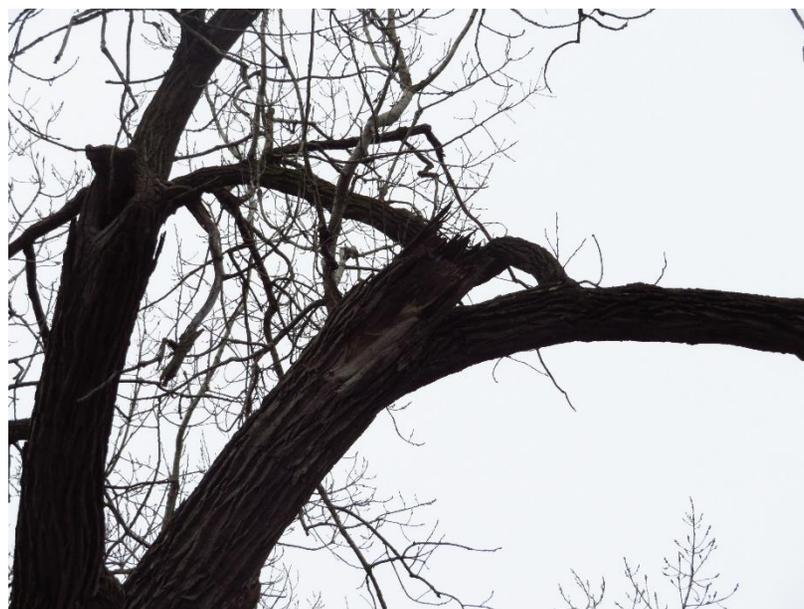
Point 2 is a 30 inch diameter silver maple that is 20 to 25 feet from loading dock of the river boat. The tree's health is poor. The tree leans toward the boat and has a large deadwood section and a large scar on northeastern side of tree that is rotting. Removal of deadwood or the entire tree is appropriate.

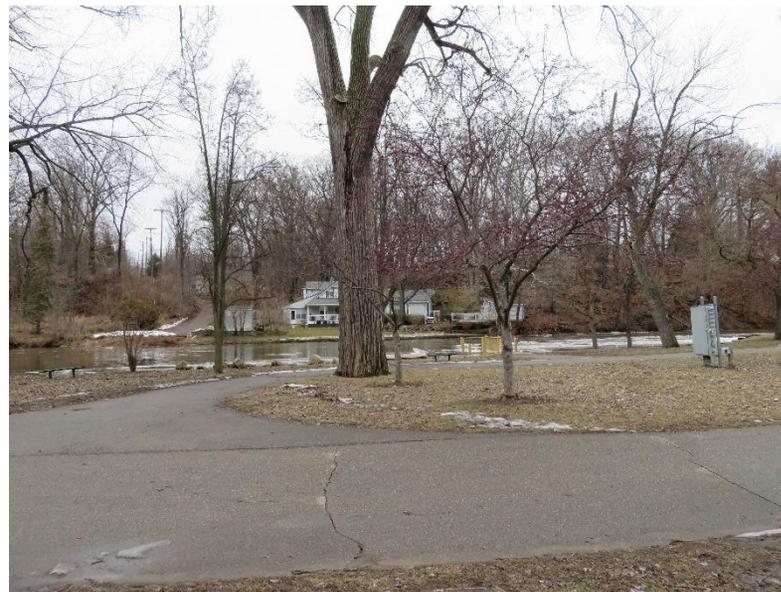
Point 3 is 70 inch diameter cottonwood located in the central grass area near the central electrical box. Overall, the trees health appears to be good. It has extensive rot in some sections of the crown which appears to be taking advantage of wounds caused by storms. Crown reduction pruning is recommended in those areas to reduce the weight on the limbs involved. Deadwood should be removed throughout the crown.

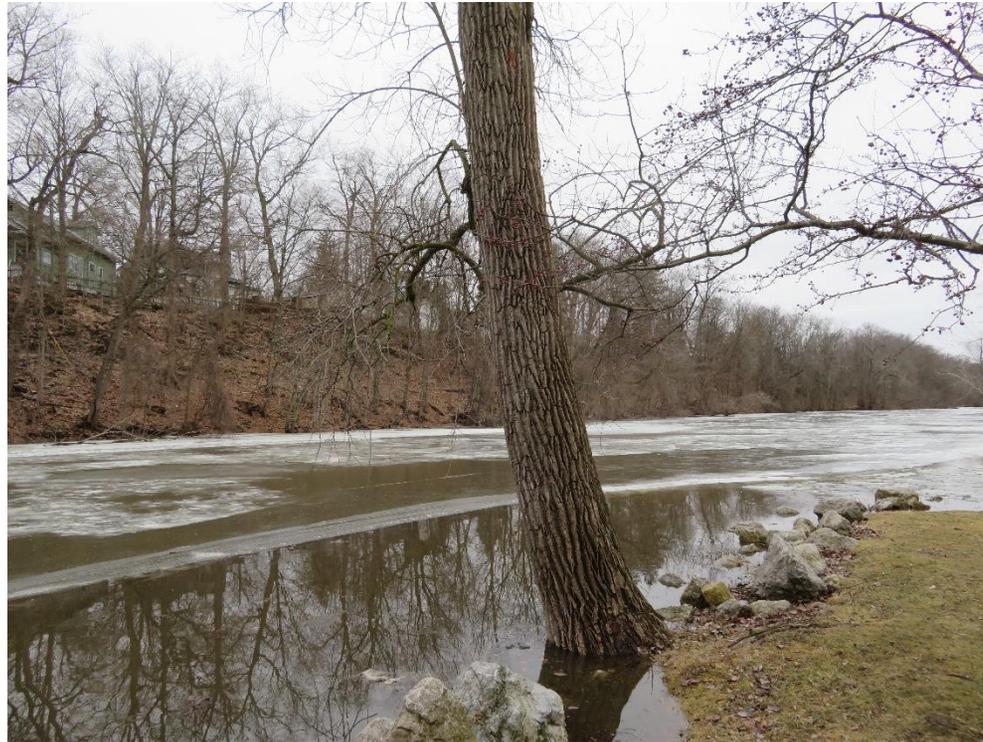
Point 4

Point Four is a 34 inch diameter, 40 foot tall cottonwood tree located on the south bank of the island that is leaning to the south. The tree is near the Steven H. Wilton memorial crab apple tree. This tree is in poor health and is in the process of uprooting. The tree has severe root and lower trunk rot and should be removed . If the tree fails there is a good chance it will take a large portion of the stream bank into the river which will promote erosion.

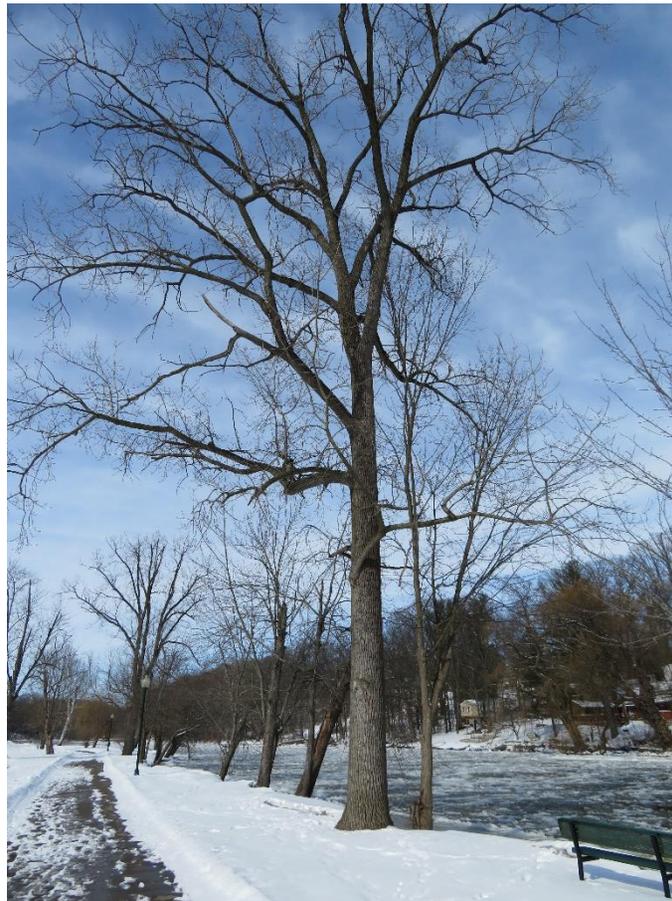
Point 5 is a 28 inch diameter cottonwood located on north bank of the park. Its health appears good but it does have some deadwood that should be pruned out of the tree.

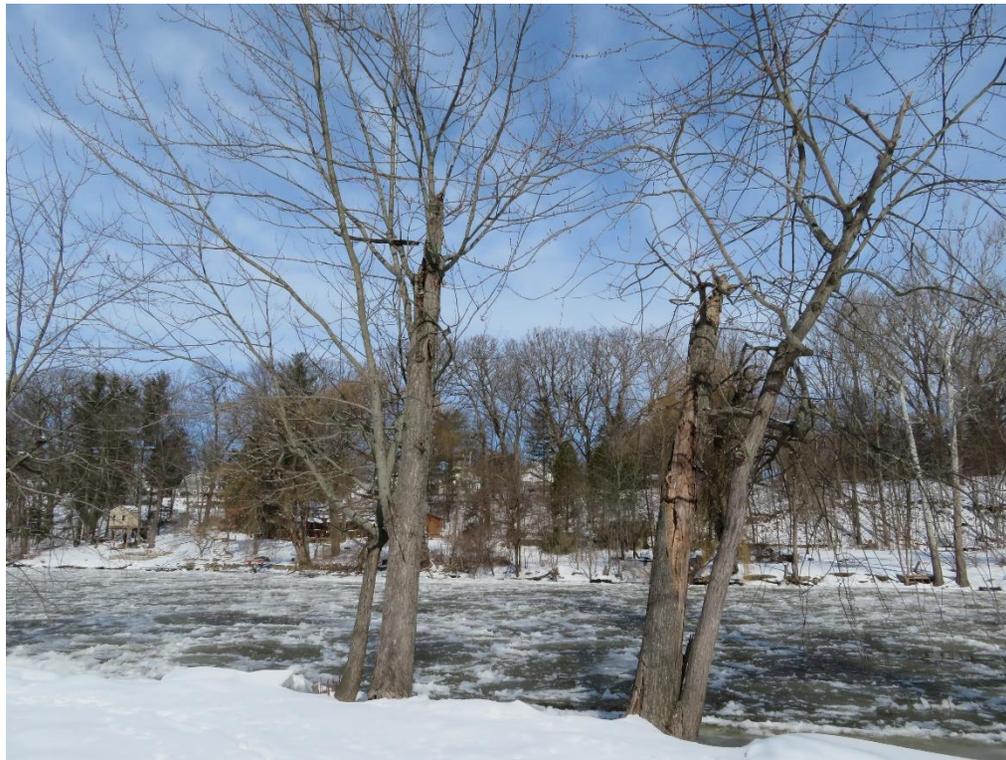
Point 6 is 2 trees. Both trees are 30 to 45 feet west of the last cottonwood. They are 12 and 14 inch diameter silver maples. Neither tree is at immediate risk of failing but tree 1 is dead, and tree 2 has had the top knocked out by storms. Tree 2 has extensive rot in the crown and will never be good tree. It is recommended that both trees be removed.

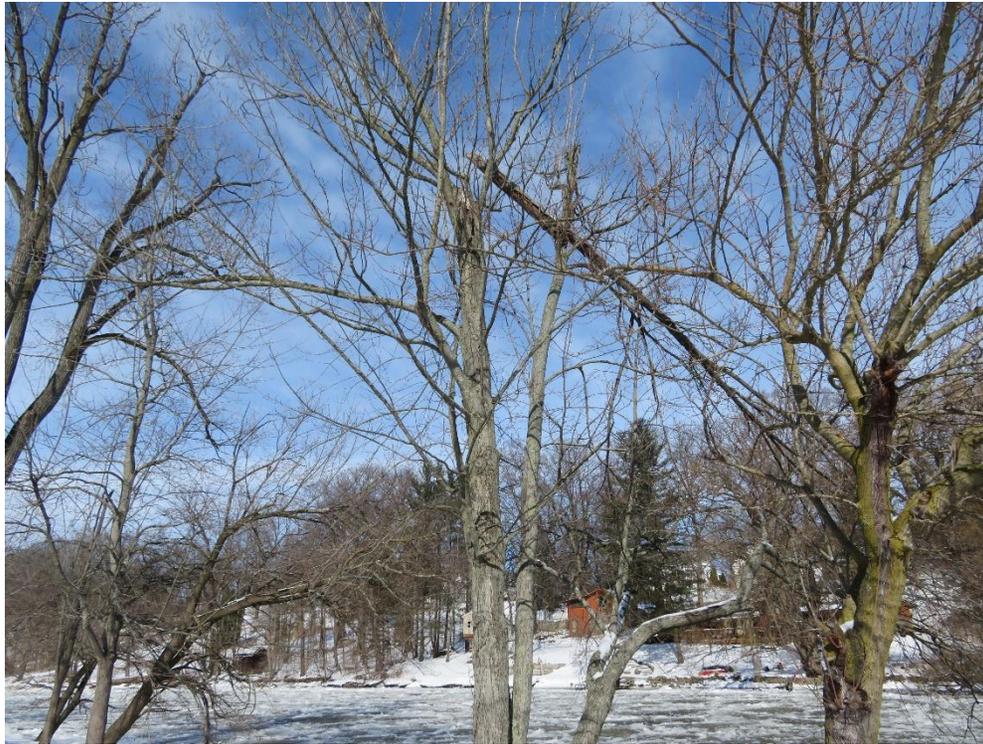
Point 7 is a 12 inch silver maple with 4 inch diameter broken hanging branch 20 feet above ground. The branch should be removed as soon as possible. The trees overall health appears good.

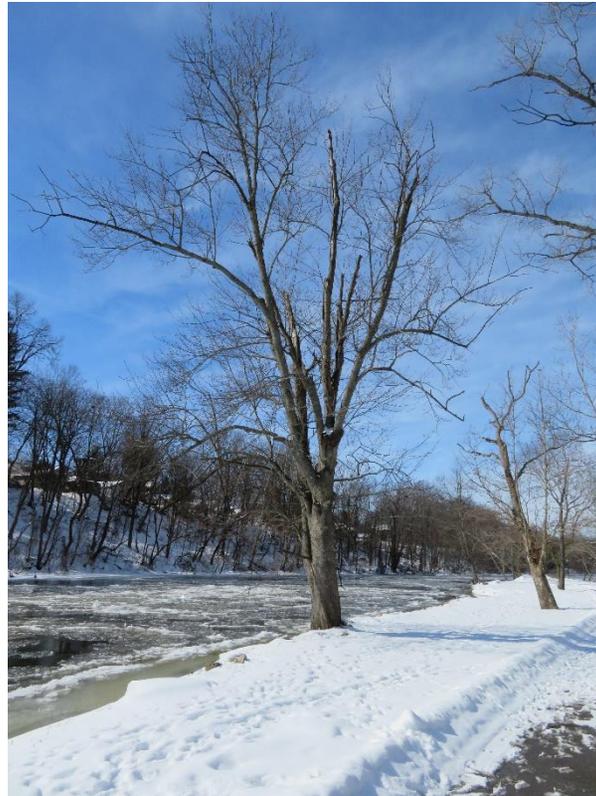
Point 8 is a 30 inch diameter silver maple that is 40 feet tall. It has a substantial amount of deadwood up to and above 10 inches in diameter. This tree is in decline but it appears it does not need to be removed at this time. The deadwood should be removed.

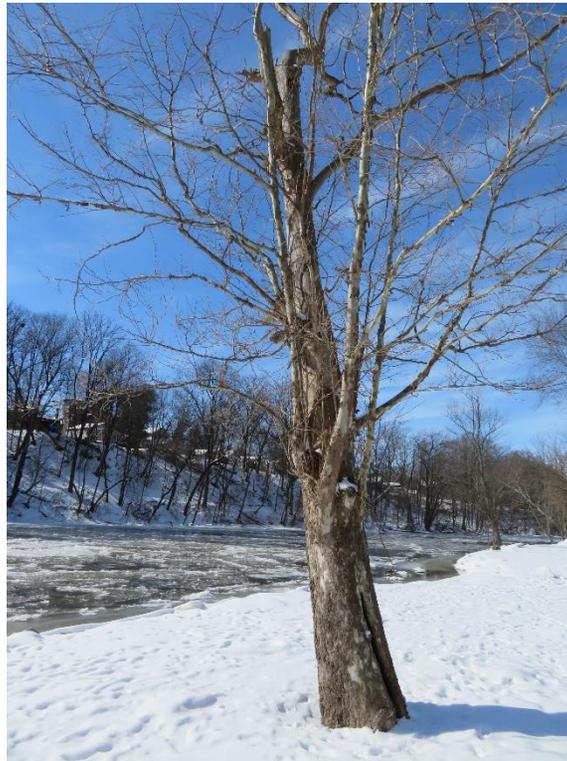
Point 9 is a 26 inch diameter sycamore with a large hollow at base which predisposes it to whole tree failure. The tree has significant deadwood in the crown. The tree is 25 to 30 ft tall and is in decline. Tree removal should be considered. It is located just south of the sidewalk.

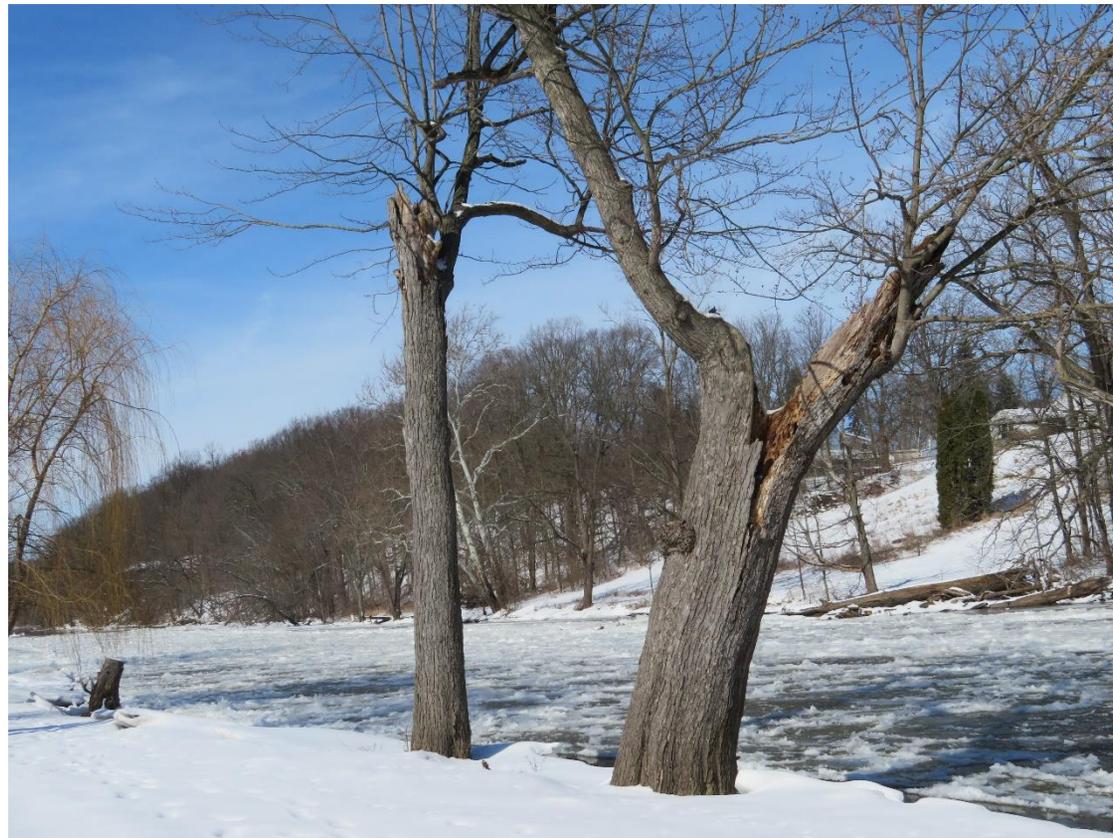
Point 10 is 2 trees, 34 and 20 inch diameter silver maples. The 34 inch silver has major trunk rot and hollows. Most of the trees crown is missing and the branches that remain are growing on a rotting trunk. The 20 inch diameter tree has extensive deadwood and a large section of the top is missing. The remaining limb is growing on a rotted base and is subject to failure. Consider removal of both trees.

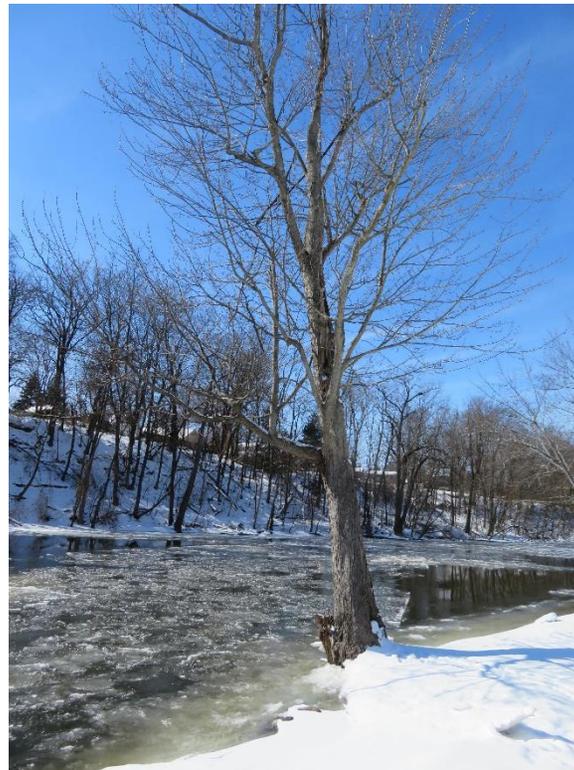
Point 11 is a 28 inch diameter silver maple located on the south bank of the island. The base of the tree is entirely hollow and has only a small portion of the trunk holding the tree up. The crown of the tree has a spiral hollow which is a major defect. Tree leans toward the south river bank. Removal of this tree should be performed as possible.

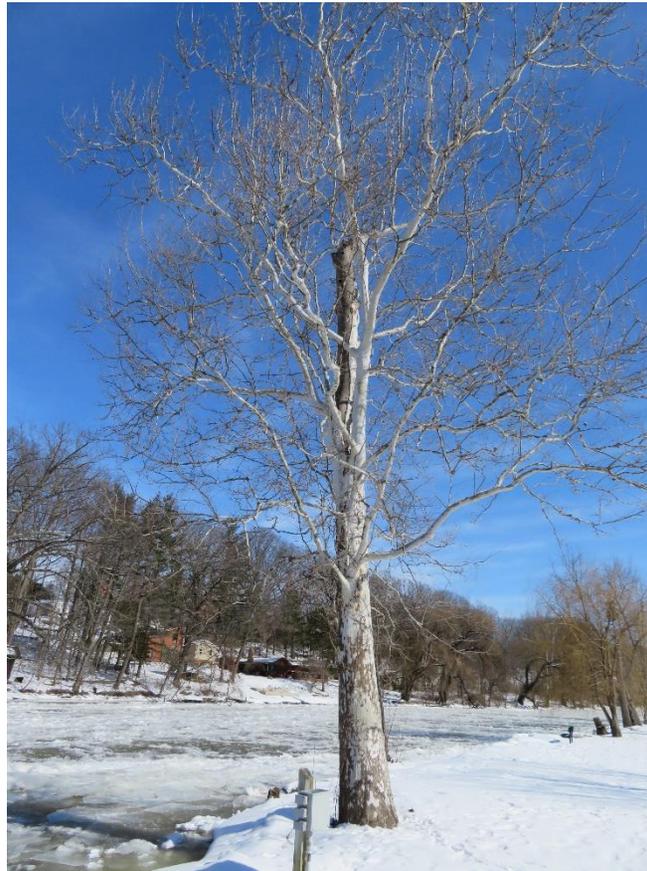
Point 12 is a 30 inch diameter 40+ foot tall sycamore located along the south bank of the island near the west end of the island. The tree has a large section of dead trunk supporting several limbs. The weight on the rotten area should be reduced through pruning. This tree will need to be removed due to rot within an estimated 10 years.

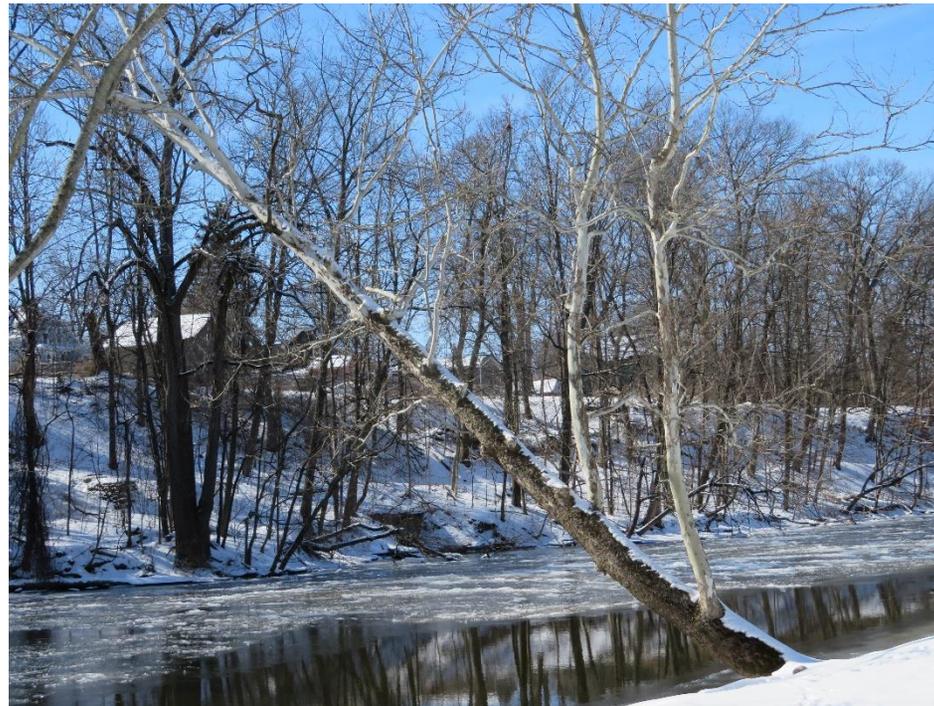
Point 13 is a sycamore located on the far western end of the island. It leans at approximately a 45 degree angle over the river. It has been in this state for many years as is evidenced by the growth of limbs near the base of the tree growing vigorously upward, toward sunlight. The tree appears stable and does not pose a risk to island users. The trees root system is unlikely to fail soon because it has adjusted to the trees growing conditions.
