**CITY OF GRAND LEDGE
SEVEN ISLANDS DAM REPAIR OPTIONS**

NOVEMBER 2014
PROJECT NO. 13008.00

City of Grand Ledge Seven Islands (Mudges) Dam Repair Options

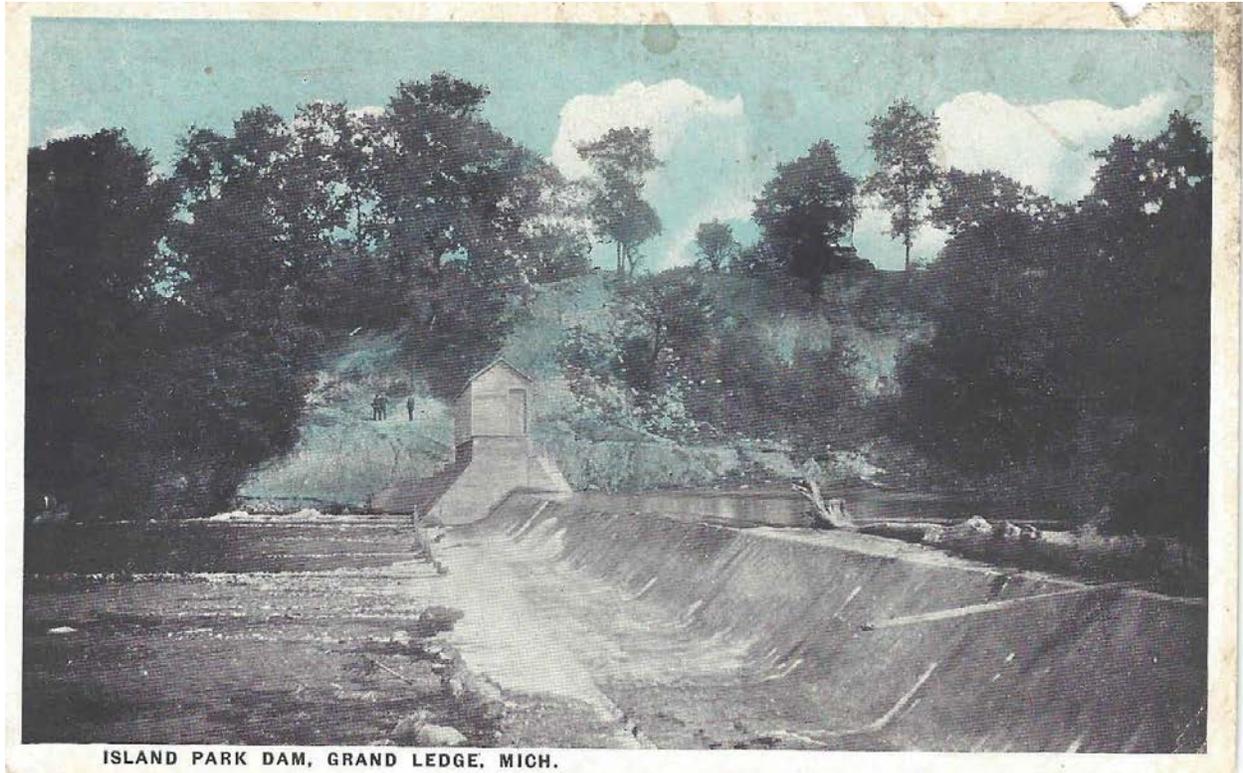
The Seven Islands / Mudges / Island Park Dam (Dam) spans the Grand River in the City of Grand Ledge, and was constructed in 1921 to raise the water level on the Grand River. The Dam consists of two main components: the long spillway, a concrete structure over which the water flows; and a gate structure, made up of seven 6-foot wide gates that can be raised or lowered to control the water level behind or upstream of the Dam. Note that the City's Island Park and downtown are upstream of the Dam.

The Dam is approximately 310 feet long, including a fish ladder on the south river bank. The main spillway is approximately five to six feet high and 220 feet long, constructed as a timber crib filled with rocks and capped with concrete. A gate control structure, approximately 75 feet long, abuts the north river bank, housing a series of seven rectangular slide gates.

The gates and the gates' support structure are failing, endangering persons occupying the area immediately downstream.
