Island Park Tree Assessment

Grand Ledge Michigan

By: The Visiting Arborist

February 2019

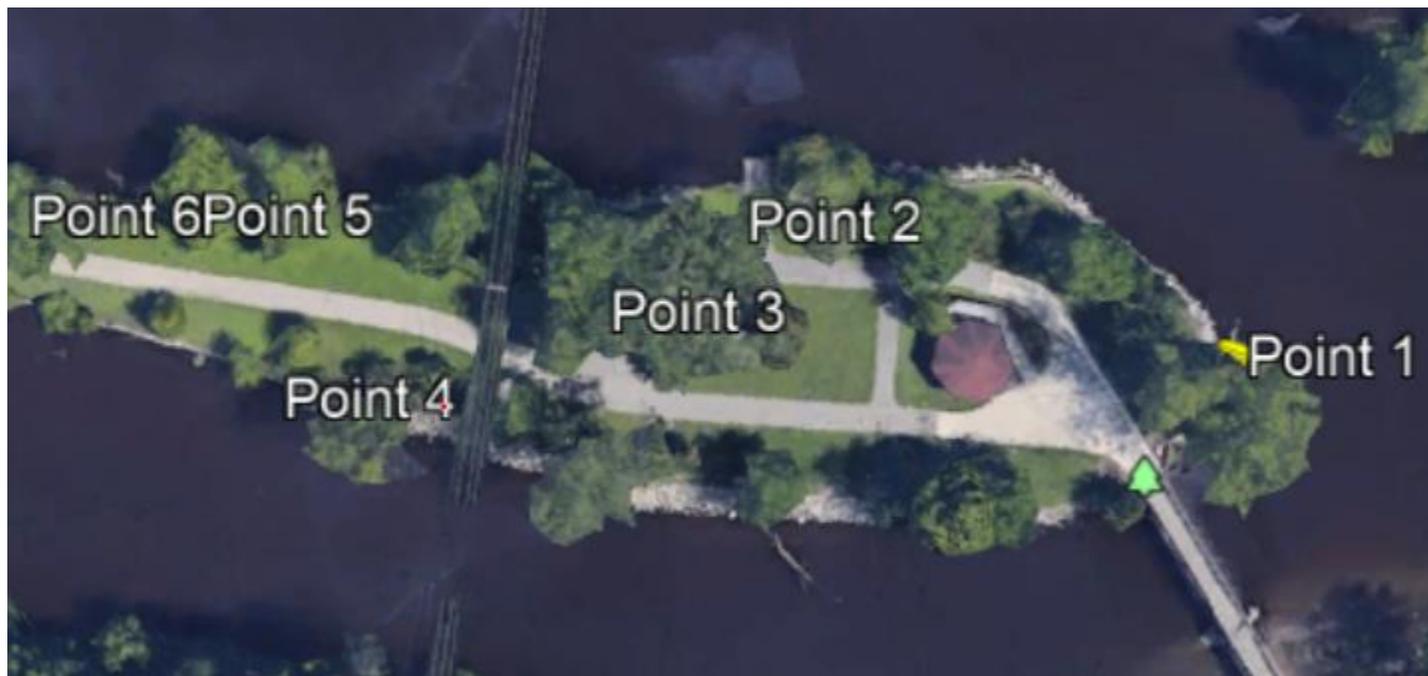
Island Park East End

The survey was a walk-by survey which gathered the following information on the trees that need work, species, diameter, height, nature of the concern. The survey started at the eastern end of the park and proceeded westward. Trees discussed are numbered on the site map (approximate locations).
